## CSC INSPECTION – SUDU756 LOWER SIDE RAIL

| Container Number<br>SUDU 7560048 | Location<br>LKCMB | Survey Date<br>28/AUG/2014 | Survey Company<br>SINSPEC | Surveyor (Print Name)<br>NR |

Manufacture Date 2010/07 This is to certify that an inspection of the lower side rails has been carried out in conformance to HSDG instructions and confirm that the container is fit or (unfit) (circle one) for continued safe service in conformance to CSC.

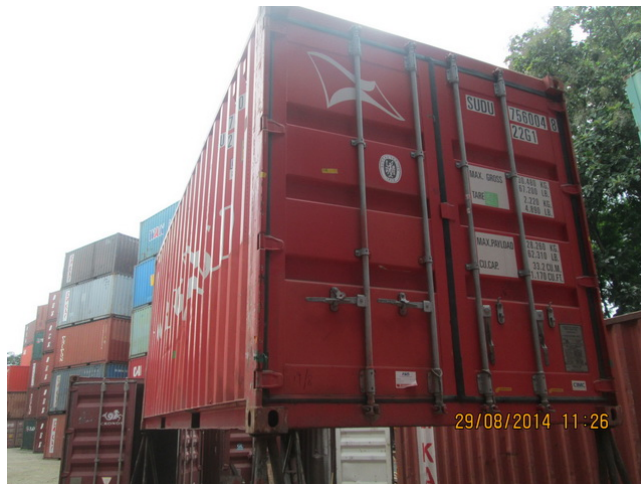
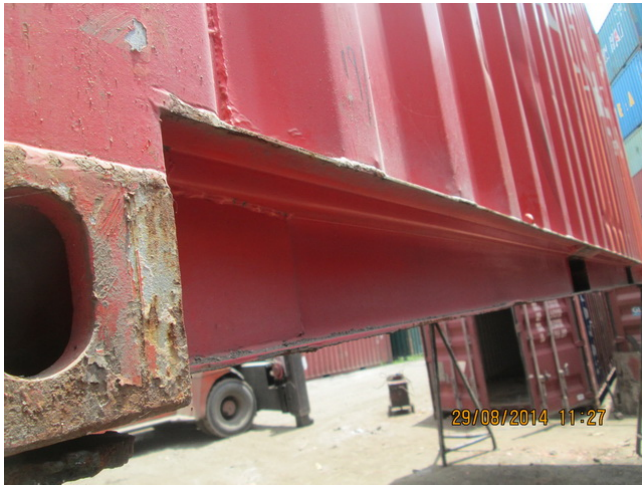
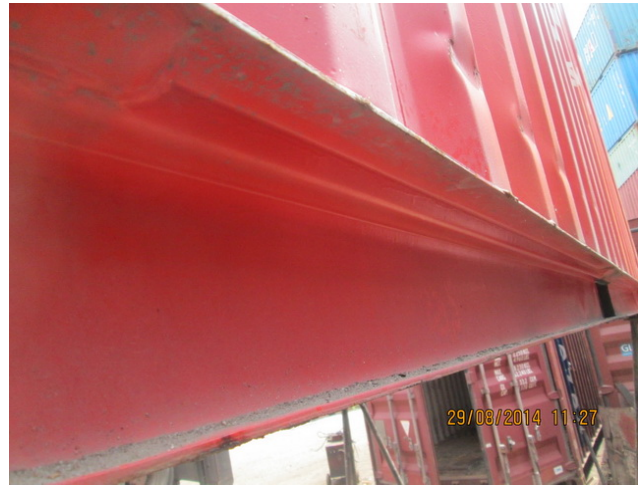
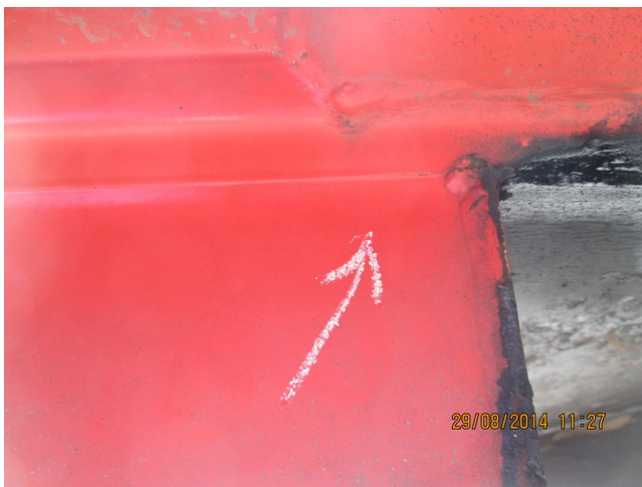
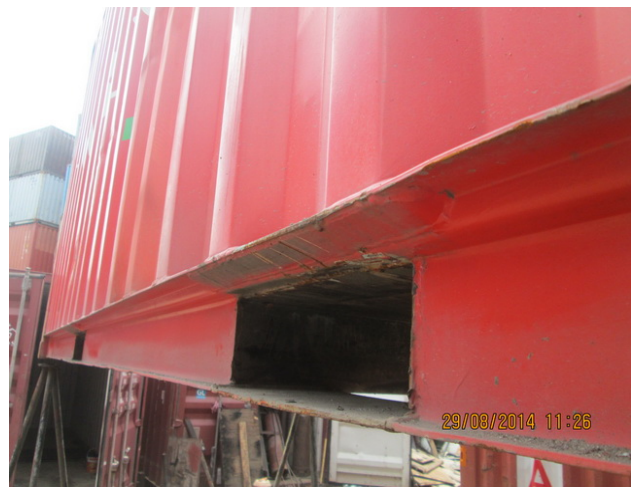
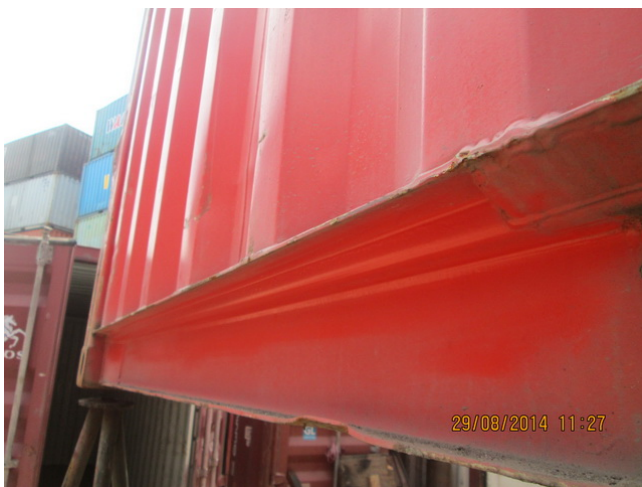
Condition Comments – 2<sup>nd</sup> Forklift pocket entry found fissure paint - No action
